Manhole Inspection Summary

Manhole # S45K2_007MH

Insp Date: 1/11/08 1:50 PM

Location Address: **4814 Fairhaven Pennington**

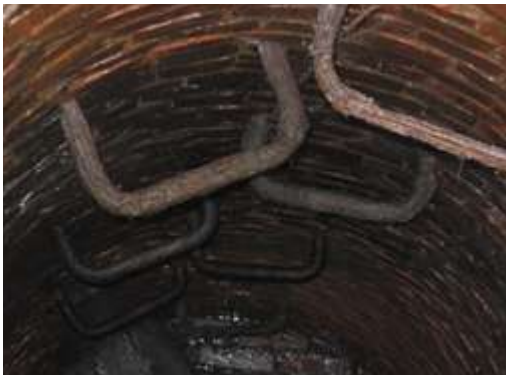
Count: **7** Missing: **0** ☒ **Corroded**

steps

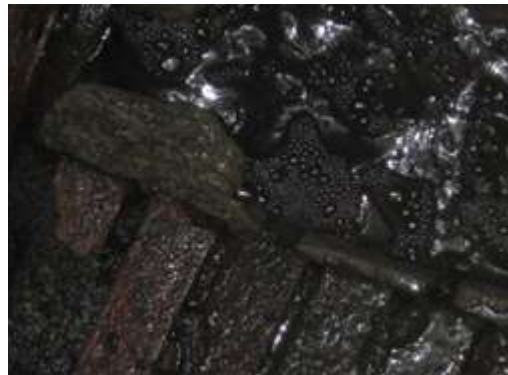
Defect 2

Condition: ☐ Sound ☐ Cracked ☐ Root Intrusion ☐ Deteriorated ☐ Leaks ☒ **Debris**

debris and loose brick in channel

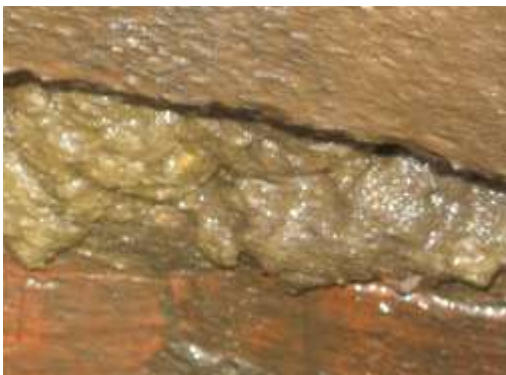
Defect 1

mortar under frame

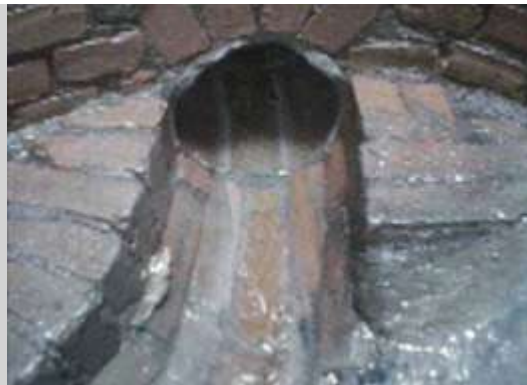
3 O'Clock Inflow

Pipe Height: **9.6** (in.) Rod and Bar (Angled)
Pipe Material: **Clay** ☐ Pipe Lined
Invert Depth: **11.86** (ft.) Flow Characteristics: **Fast**
Deposits: ☒ None ☐ Mud ☐ Sludge ☐ Debris ☐ Grease
Silt Depth: (in.) Deposits Extent:
Infiltration: **None** Pipe Seal Cond: **Broken**

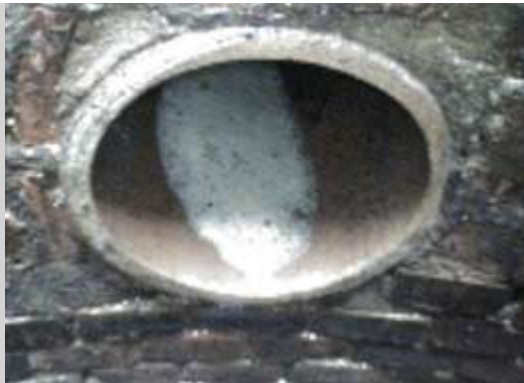
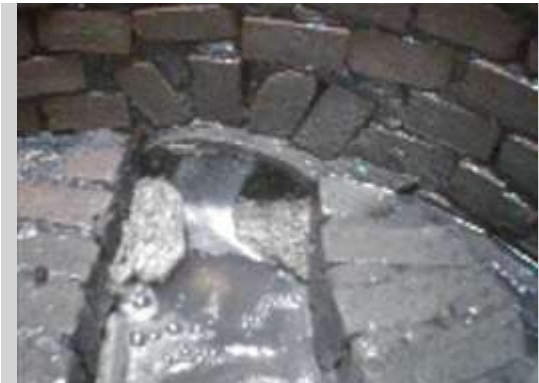
9 O'Clock Inflow

Drop: Inside	Rod and Bar
Angled: Yes	Reading: 11.01 (ft.)
	Inv Depth: 12.01 (ft.)
Drop Condition: Partly Clogged
